How to Skullcandy Lowrider

Quick and simple trouble shooting to determine the cause of a lack of sound coming from Skullcandy Lowrider OE (Over-the-Ear) headphones.

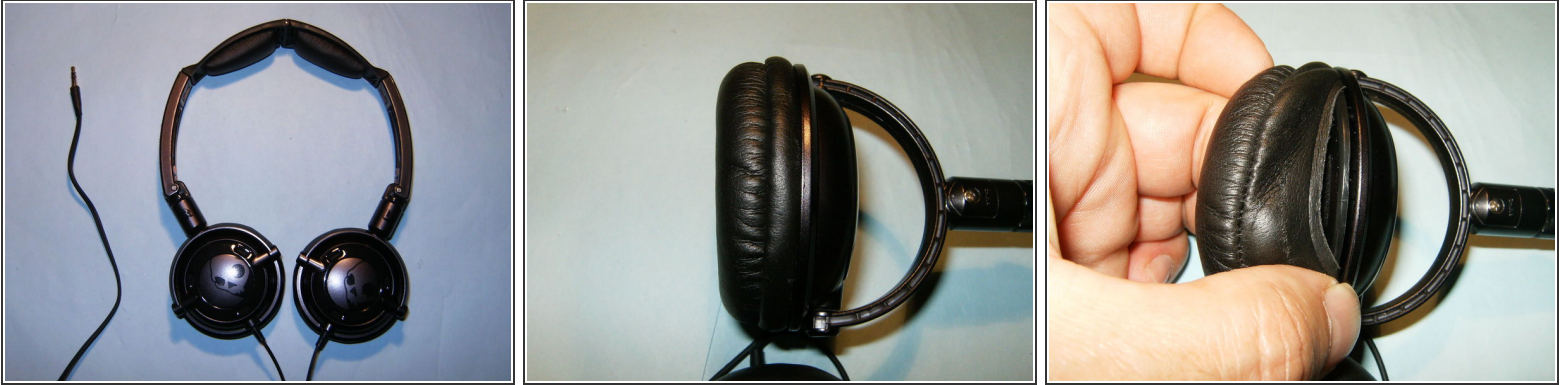
Step 1 — How to Skullcandy Lowrider

- Here is the complete headphone. I got no sound from either side when I plugged it in to my old iPod.
- The cushion is simply stuck into a space between the speaker (driver) and the case.
- Remove the cushion by gently tugging it out of that groove.

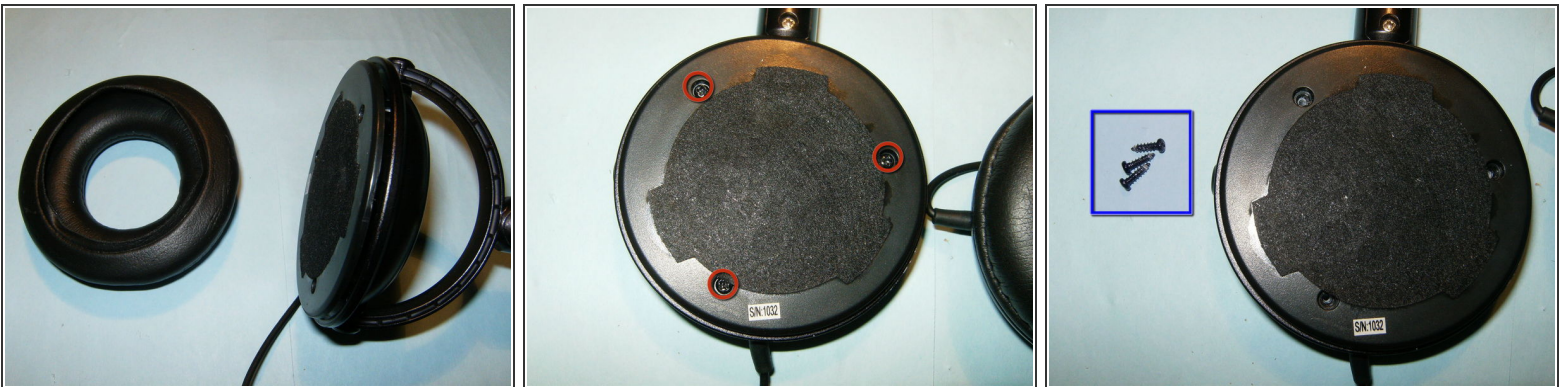
Step 2

- Here is a shot of the device with the ear cushion removed and intact (replacements are available online).
- Here are the three Phillips screws that need to be removed.
- The screws are all of the same size, so do not worry about separating them.

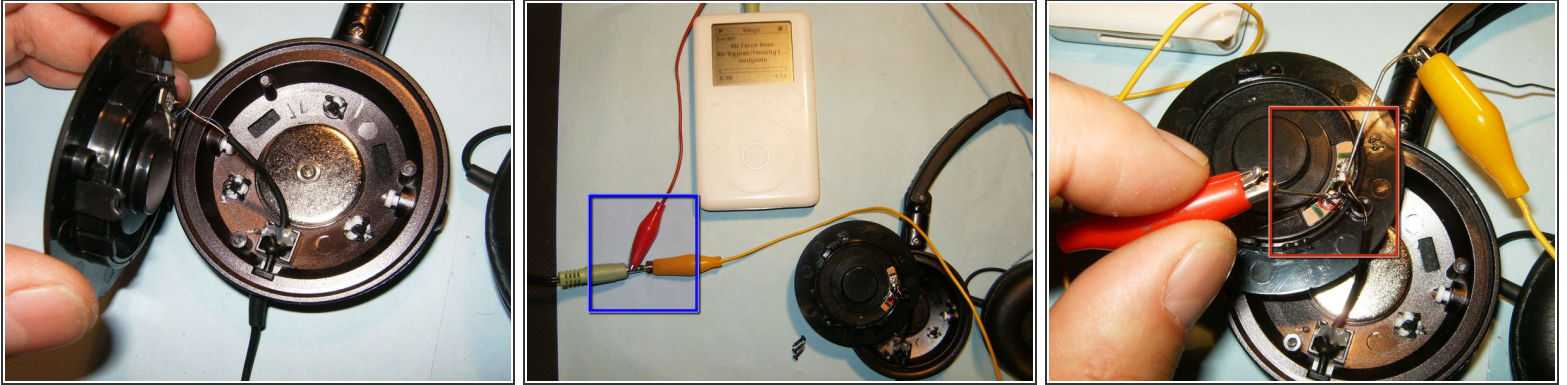
Step 3

- With the three screws removed, the driver will simply fold up to reveal the wiring. In this case, the color code for the wires is Blue for left and Gold for ground.
- Here is the way I connected some alligator test leads. Use a male-male 3.5 mm stereo cable. Attach one lead to the sleeve, the upper part of the connector, and one lead to either tip (front) or Ring (middle) of the connector.
- Attach some test points to the end of the alligator cables and touch the solder connections of the speaker (driver). In this case, there was clear sound. This determined that there was no signal going from the connector to the drivers.

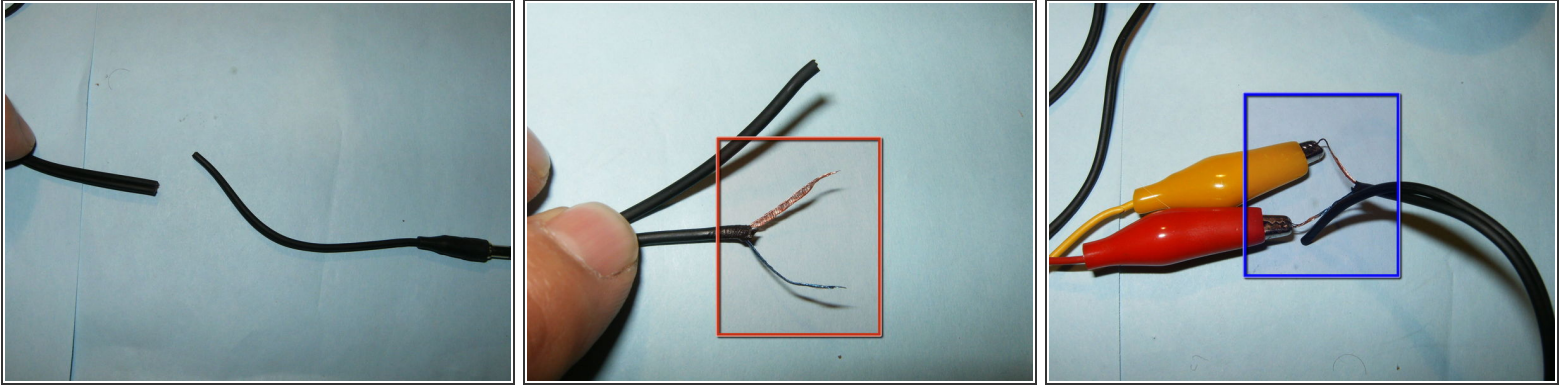
Step 4

- Cut about 3 inches off the end of the cable.
- To make sure that it was indeed the connector, and not a cracked wire further up, remove the insulation of one set of wires. The device uses one set for each side. To remove the insulation, you can use a boxcutter, a sharp knife, a lighter, etc.
- Attach the test lead from any MP3 player, as previously shown. If the reason for the non-functioning headphones was the connector, there should now be sound coming from the headphone speaker (driver). In this case, there was. Therefore, it was indeed the audio connector that was broken.

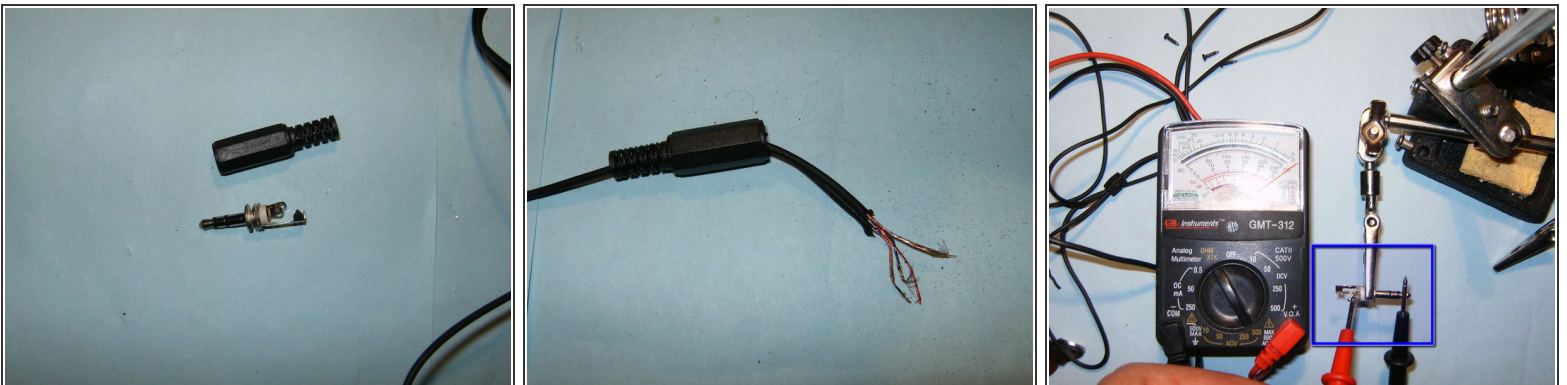
Step 5

- Here is a new 3.5 mm stereo audio connector. The cover simply screws on the actual connector.
- Place the cover in the proper direction over the wire
- Here is how to determine which solder tab fits to what part of the connector. Set a multimeter to the Ohm scale. Touching the tip and the shortest tab showed continuity.

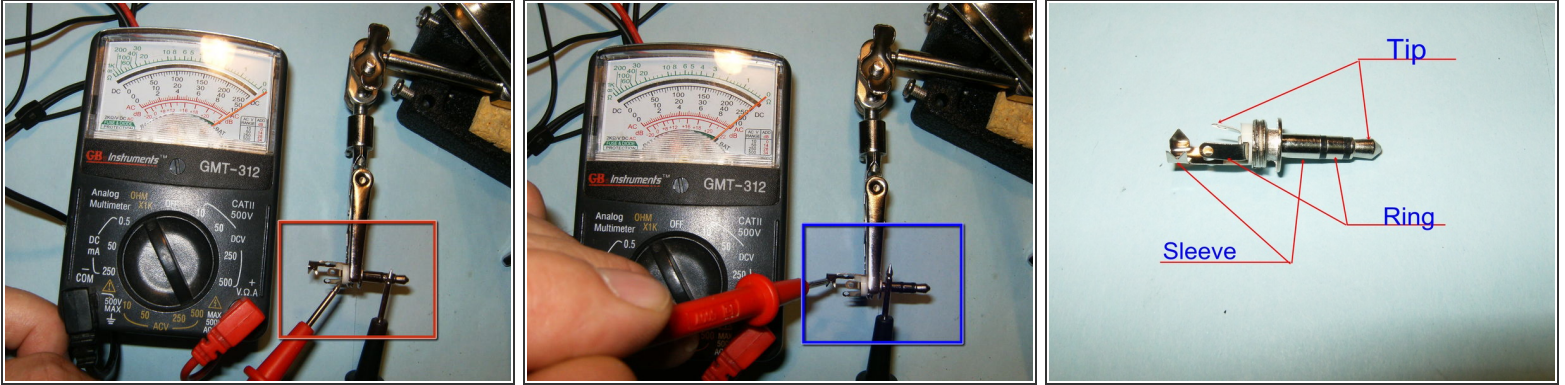
Step 6

- Since the ring (middle) of the connector and the medium size tab showed continuity, they are a match for soldering.
- Lastly, the sleeve (top) and the longest tab showed continuity. Now we have determined which parts are a match. This is important to properly connect the left and right speaker (driver).
- If no multimeter is available, here is a quick sketch of the three corresponding connections.

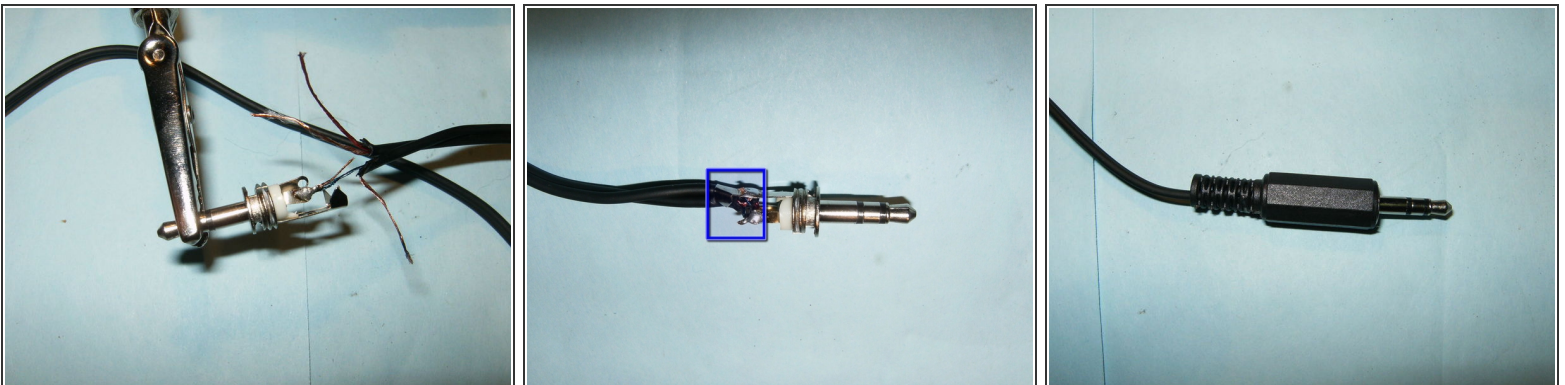
Step 7

- Most MP3 players, including the iPod, use the Tip for the left channel. Solder the Blue wire to the tip connector, the Red wire to the Ring connector, and both Gold wires to the Sleeve connector.
- When all wires are soldered to their respective connectors, squeeze the cable tab at the sleeve connector tight around the cable. This helps to keep the solder connection when the headphones get disconnected by pulling on the wire.
- Attach the cover to the audio jack connector.

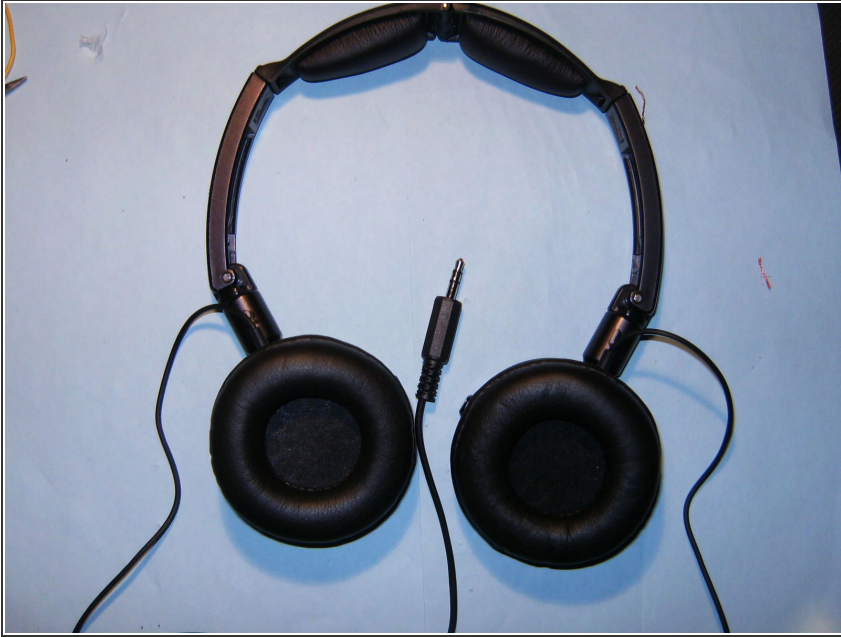
Step 8

i Reassembly was straightforward. The only tricky part was getting the cushion back on the speaker (driver), but a pair of fingernails served the purpose quite nicely. The headphones are once again fully-functioning and sound pretty good. Total cost for the repair was \$0.75 and it took me 38 minutes...not a bad job.:)

To reassemble your device, follow these instructions in reverse order.
